## PROPERTY INSPECTION REPORT

Concerning: 12345 Haughland Dr. Cypress, TX. 77433

By: **Rod Scarborough** TREC License # 7189

**February 20, 2010**

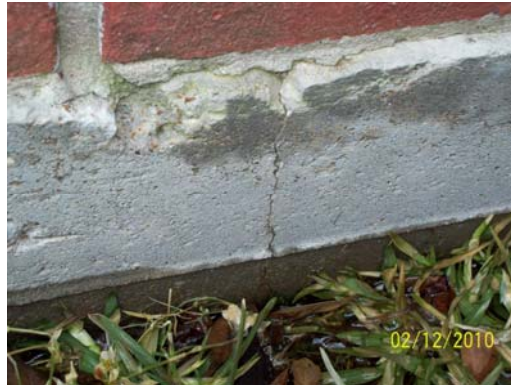
☒The foundation appeared to be functioning as intended, however there was a hairline crack in the foundation on the northwest and northeast side of structure. Recommend continuing to monitor.

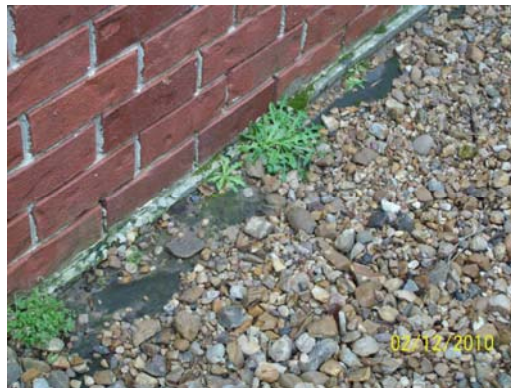
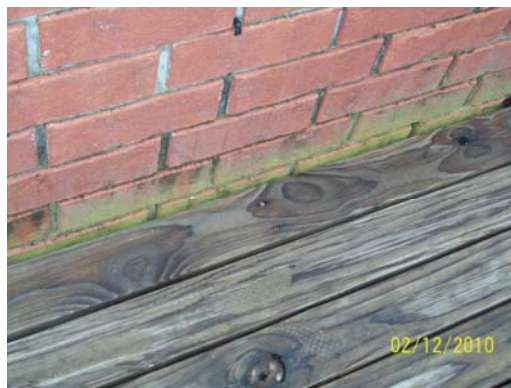
☒ There were areas around the structure that were not accessible due to improper grade clearances and decking material against the foundation wall at various locations around structure.

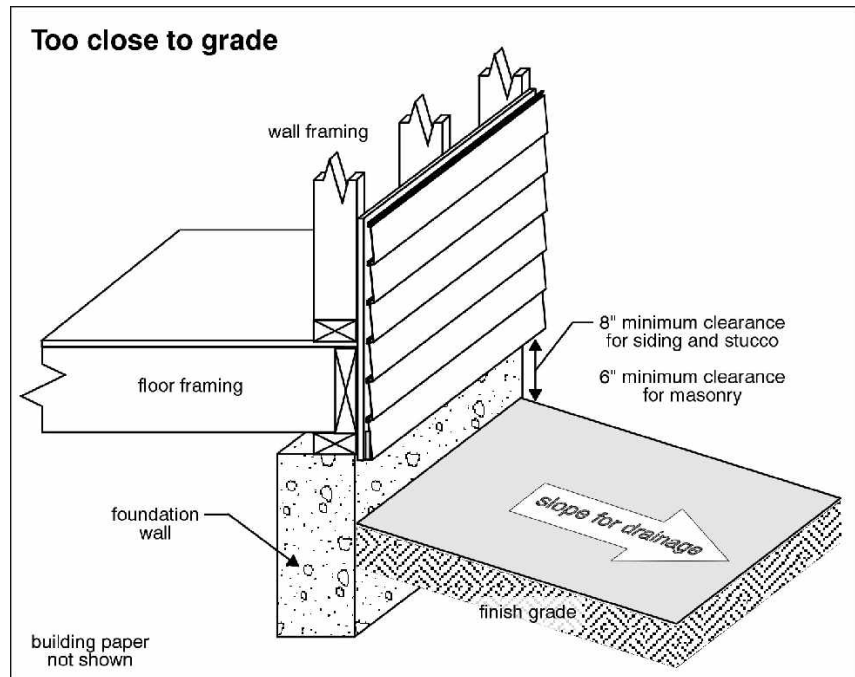
☒ Grade appeared to be flat and appeared to slope toward structure at various location. Recommend continuing to monitor.

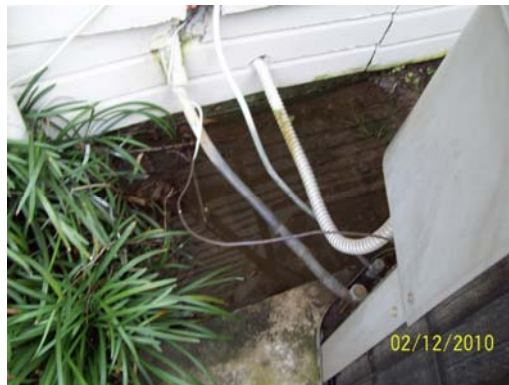
☒ There was significant ponding around structure at various locations. Recommend modifying grade to move water away from foundation and eliminate ponding.

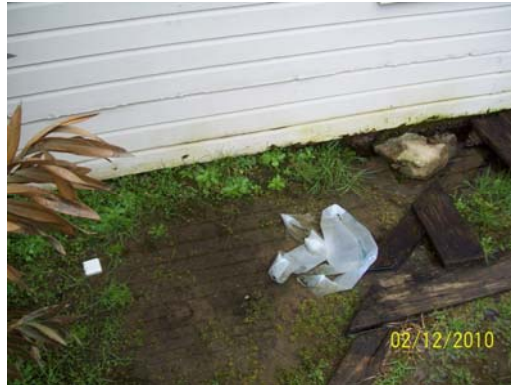
☒ Some gutter down spouts did not divert water from foundation properly, down spouts should divert water away approximately 5' from foundation.

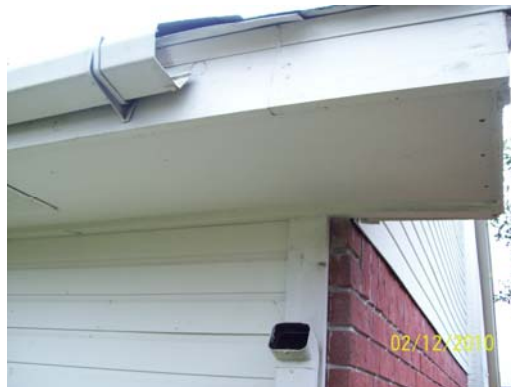
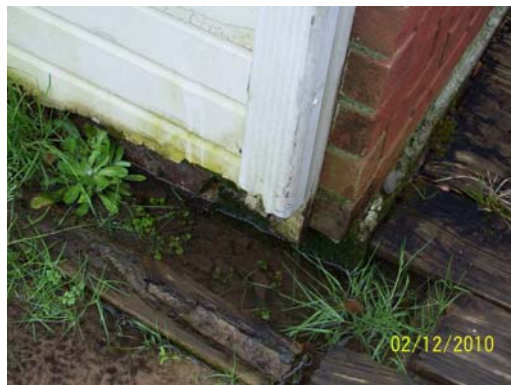
☒ Gutter down spouts/connection on southeast side of structure was damaged and was not properly connected to gutter.

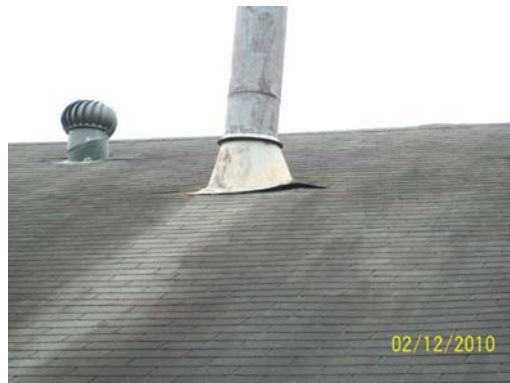
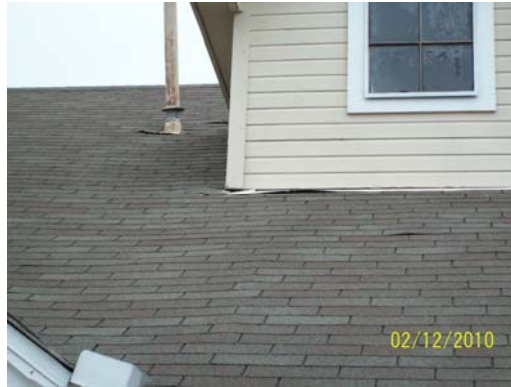
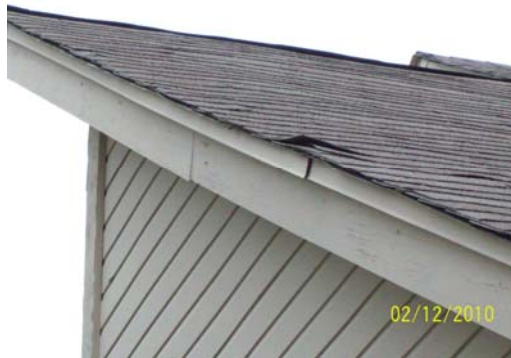
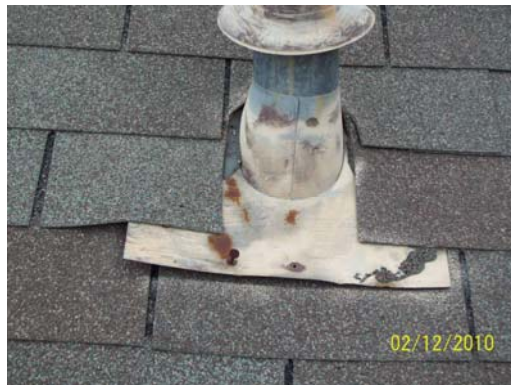
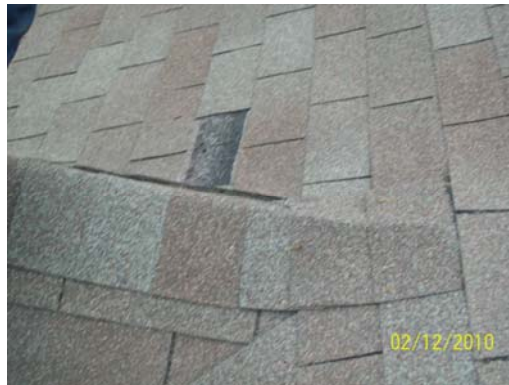
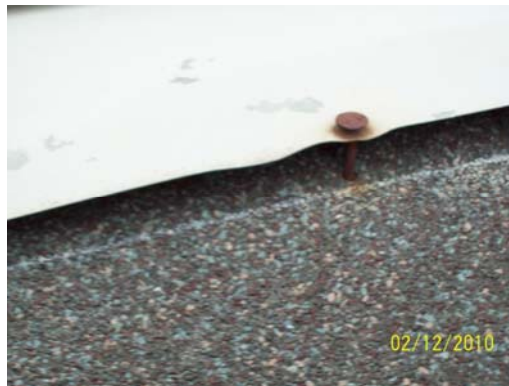
☒ Roof appeared to be functioning as intended however there were damaged shingles, exposed/popping nail heads, uplifted shingles and flashing at various locations and the roof showed signs of aging. There were signs of an active roof leak in the attic and signs of previous/existing leaks at various locations within the attic space. Recommend having a roofing professional do a complete evaluation.

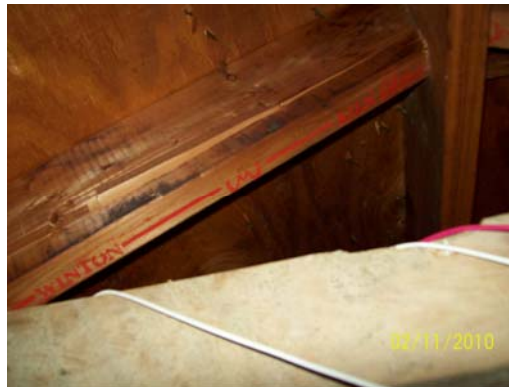
☒ Observed a cracked rafter between the water heater flue vent and the chimney flue vent.

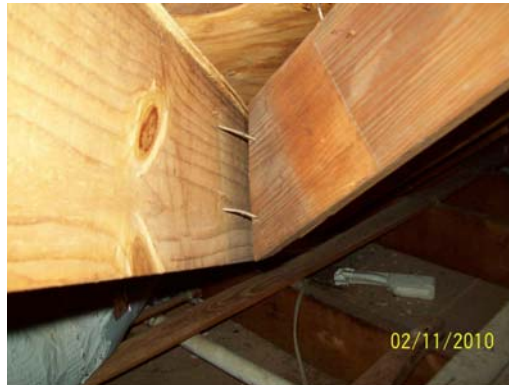
☒ Rafter pulled/knocked away from valley rafter on north side in attic area.

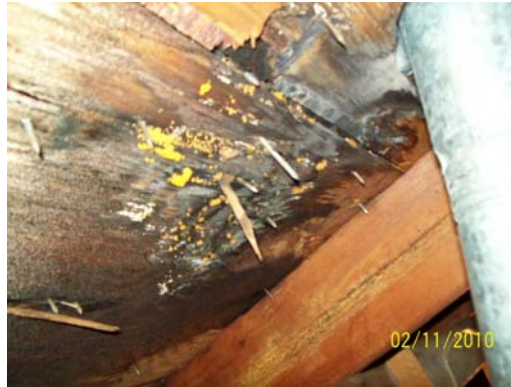
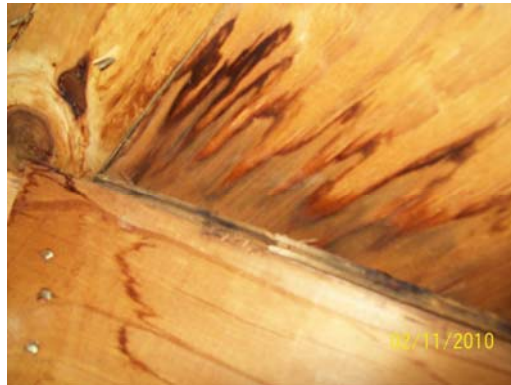
☒ There were signs of an active roof leak in the attic and signs of previous/existing leaks at various locations within the attic space. Recommend having a roofing professional do a complete evaluation.

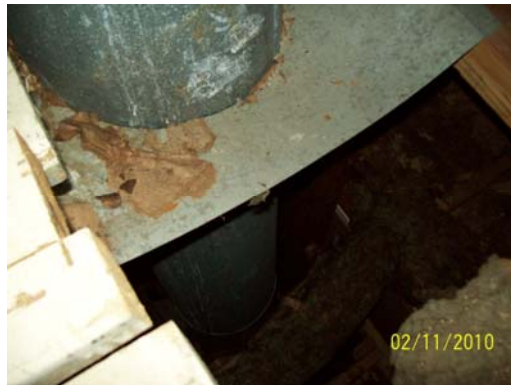
☒ Fire blocking for chimney flue not installed.

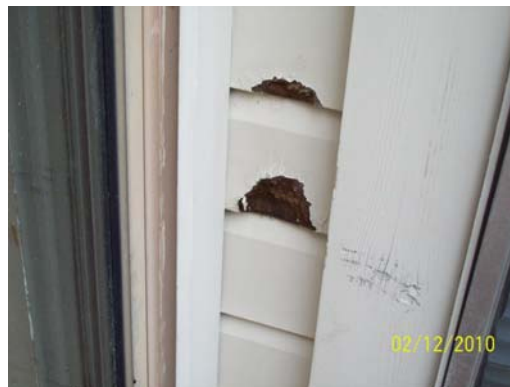
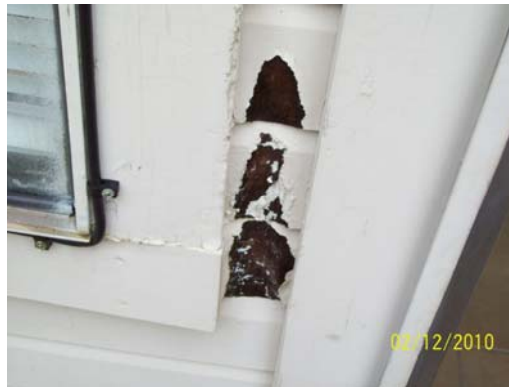
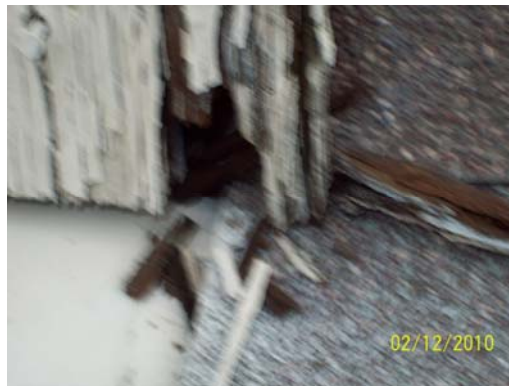
☒Exterior walls appeared to be functioning as intended however there was wood/siding rot at various locations around the structure.

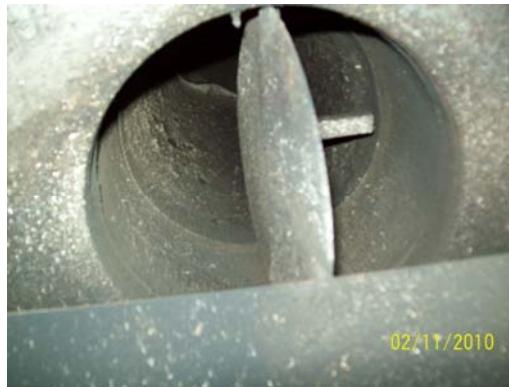
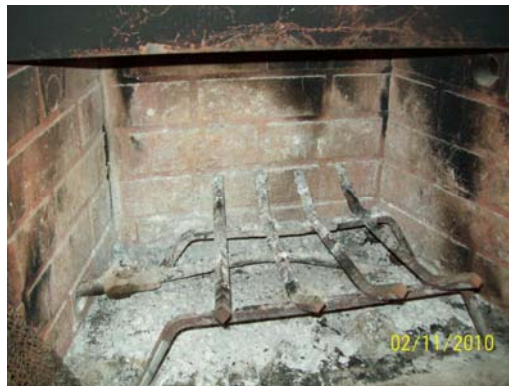
☒ Cracked tile on right side of fireplace and missing grout around tile on left side.

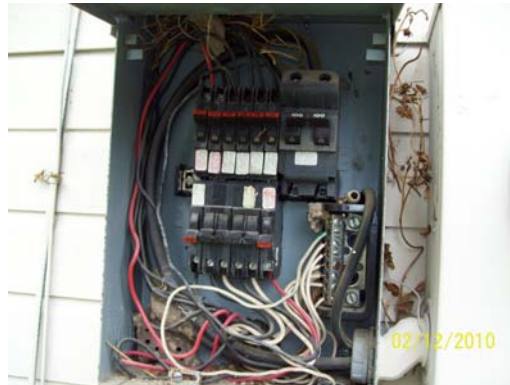
☒ Dead front was not in place. Recommend installing for safety.

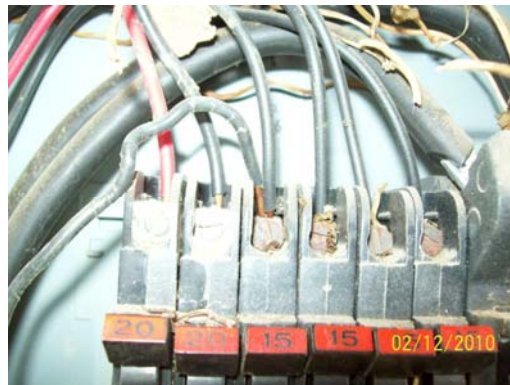
☒ 15 amp circuit breaker is double tapped.

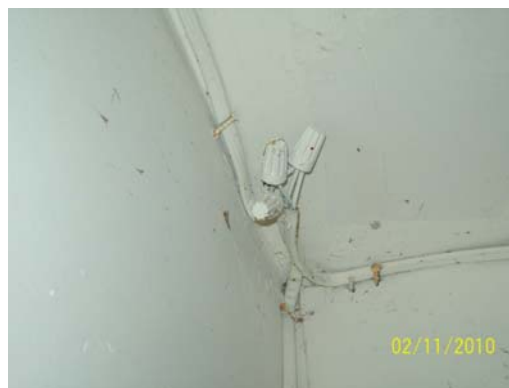
☒ Junction box not installed at connection for front porch light conductors and in attic area.

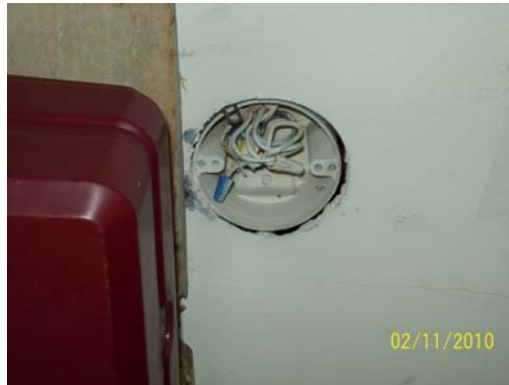
☒ Cover plate missing on junction box in ceiling in the garage.

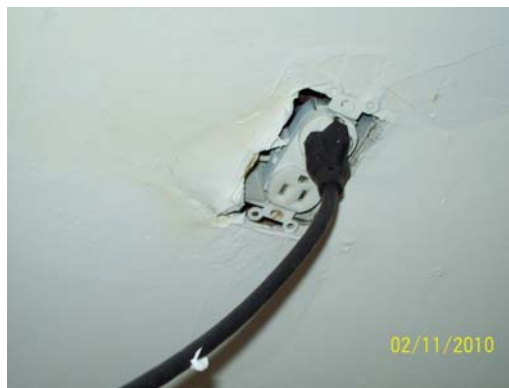
☒ Cover plate missing on receptacle in garage ceiling.

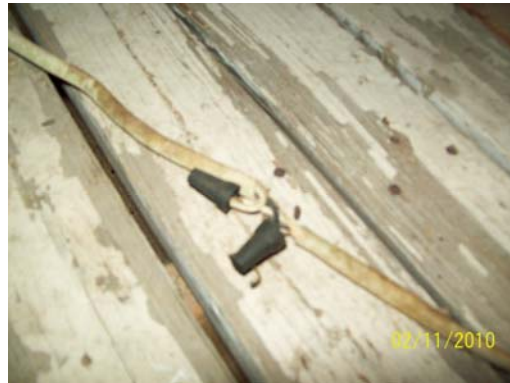
☒ Improper conductor connections in attic.

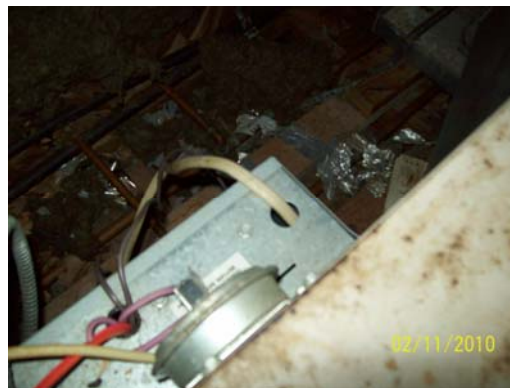
☒ Power supply conductor for the HVAC equipment in attic is not properly protected.

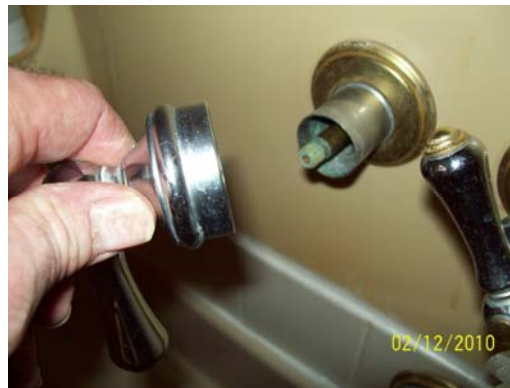
☒ The hot water valve in the master bath was not secured and came off when the valve was turned on.

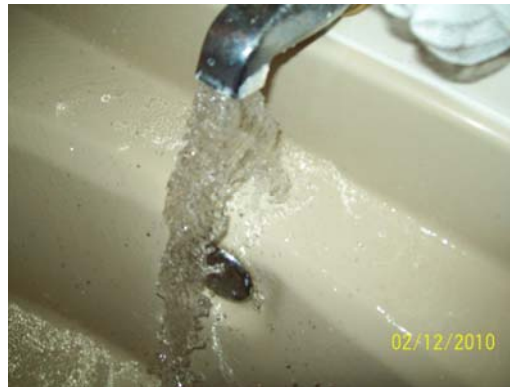
☒ When the water is turned on in the bathtub in the master bathroom and the diverter is set to tub mode water from the faucet sprays all over the bathtub rim.

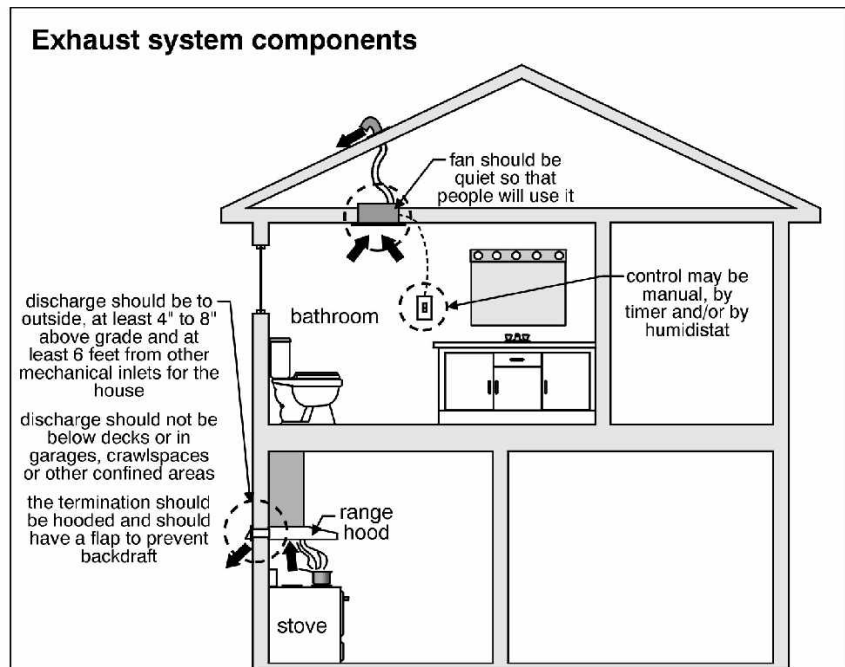
☒ The exhaust fan in the hall bath appeared to vent into the attic. This should be vented to the exterior.

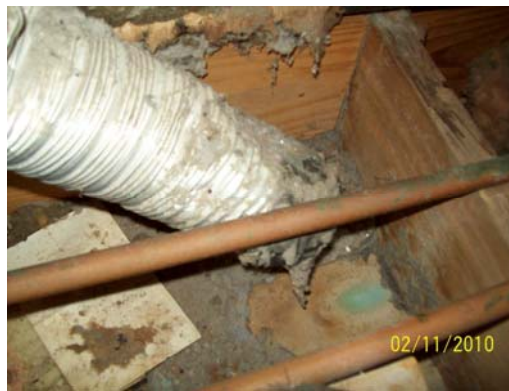
☒ Dryer vent terminated in the attic. This should be vented to the exterior.
