PROPERTY INSPECTION REPORT

Concerning: 1234 Sample Anytown, TX.

By: **Rod Scarborough** TREC License # 7189

August 3, 2010

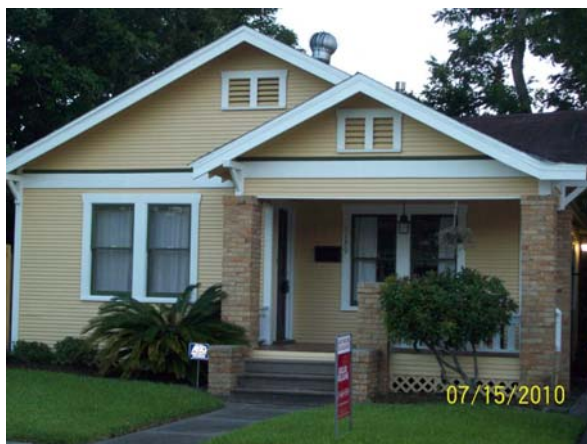
Front of home

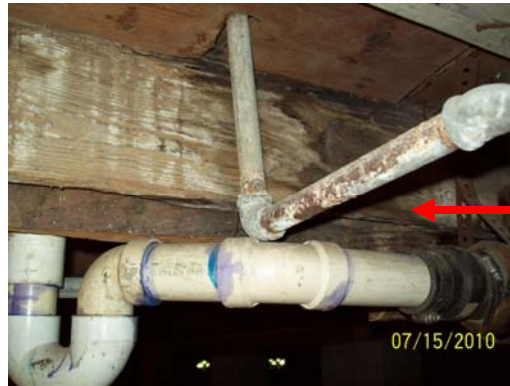
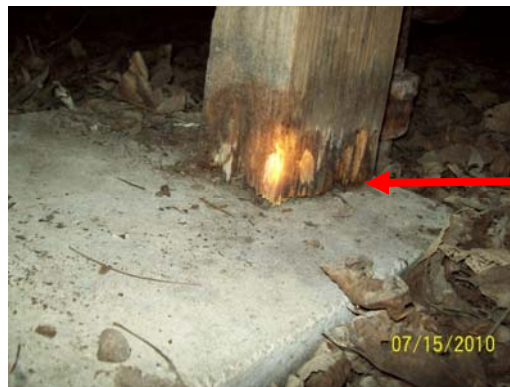
Wood damage due to moisture penetration.

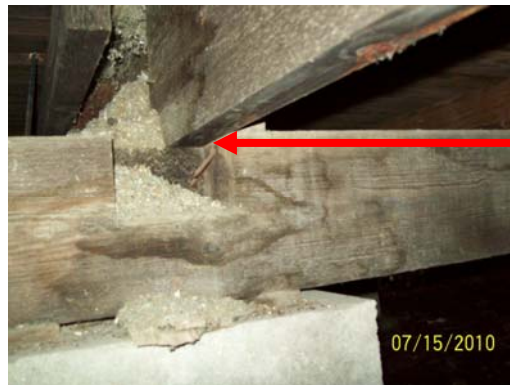
Girders and floor joist not properly supported at various locations.

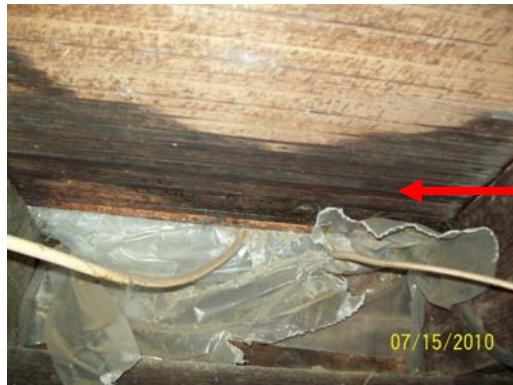
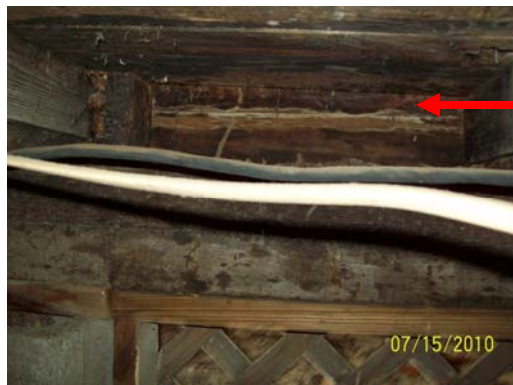
Signs of previous/existing moisture penetrations at various locations.

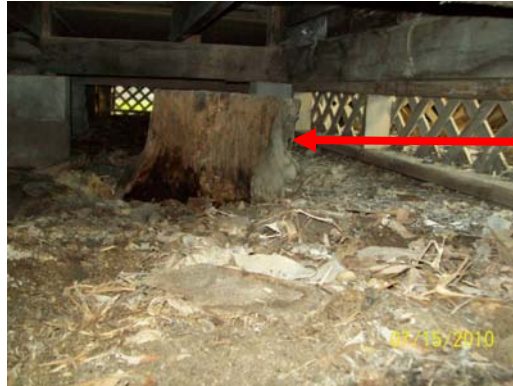
Tree stump under structure.

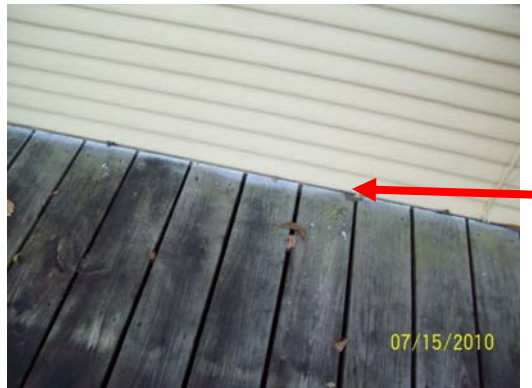
There is a deck on the south side of the structure that does not have the proper clearance as required.

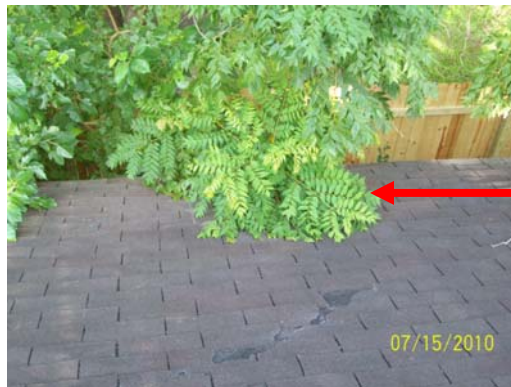
Tree limbs are near or in contact with the roof. Tree branches should be kept at least 6 feet off of the roof to prevent them from rubbing and damaging the shingles.

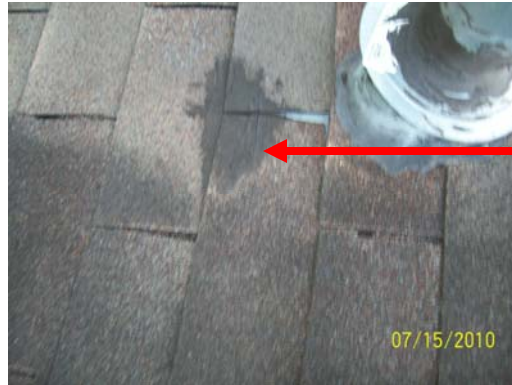
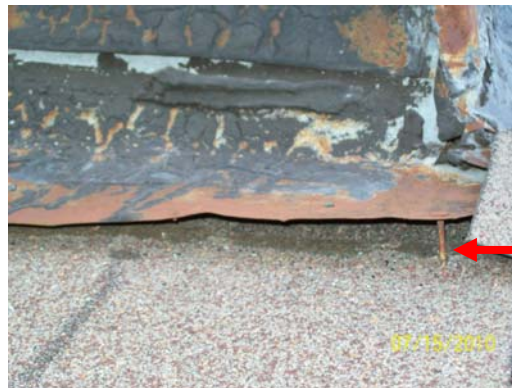
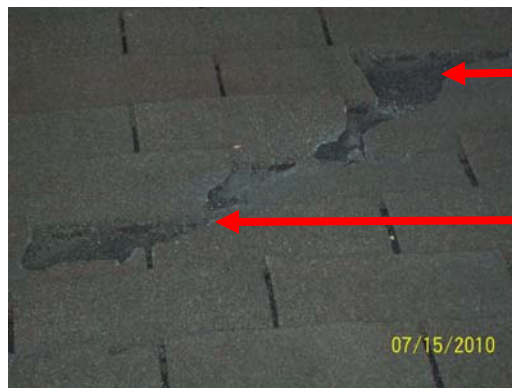
Roof showed signs of previous repairs. Exposed nail heads/popping nails at various locations and damaged/missing shingles at various locations.

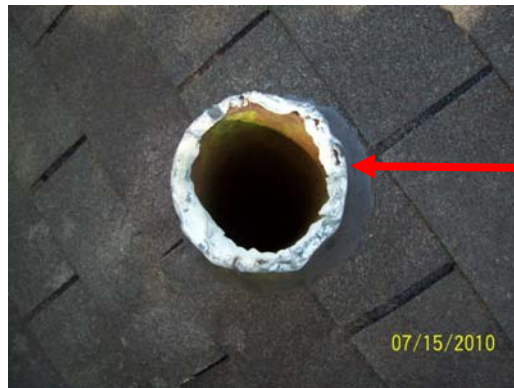
Lead roof jack is damaged.

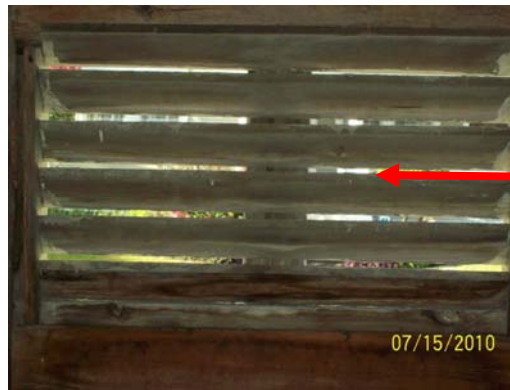
Gable vents missing screens/wire mesh.

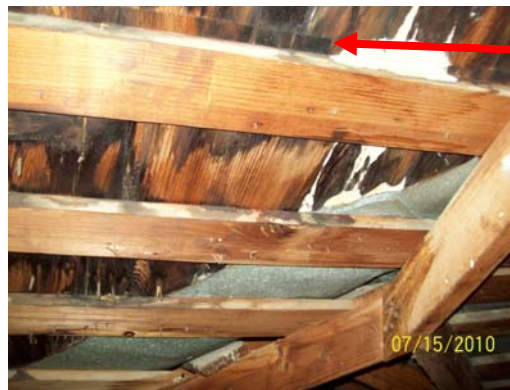
Signs of previous/existing moisture penetration at various locations throughout attic.

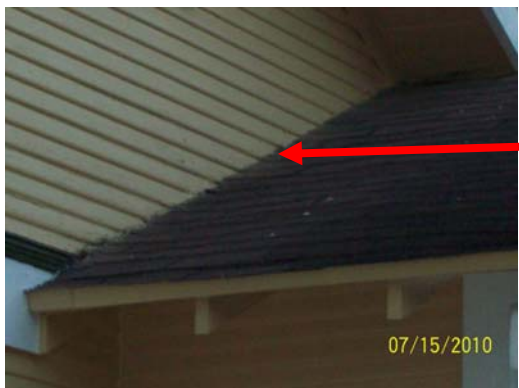
Exterior walls should be cut back a minimum of 2" where the wall meets the roof line.

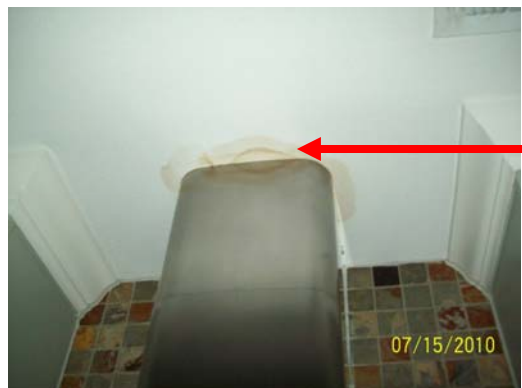
Signs of previous/existing moisture penetration in kitchen above range.

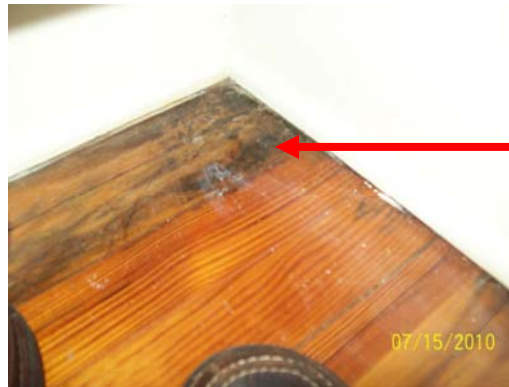
Signs of previous moisture penetration to wood floor in the closet in the southwest bedroom.

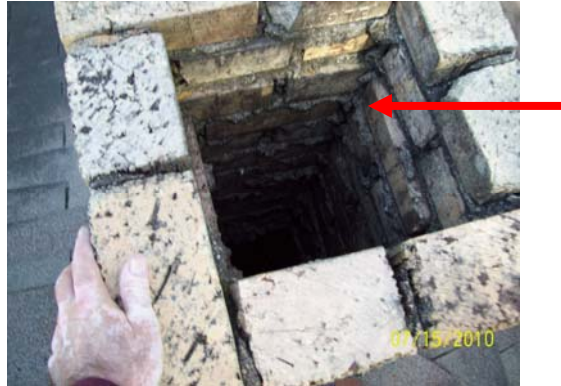
Chimney cap is missing

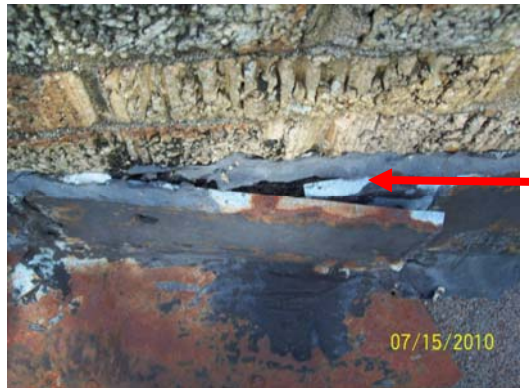
Flashing around the chimney is pulling away from structure and the sealant has deteriorated.

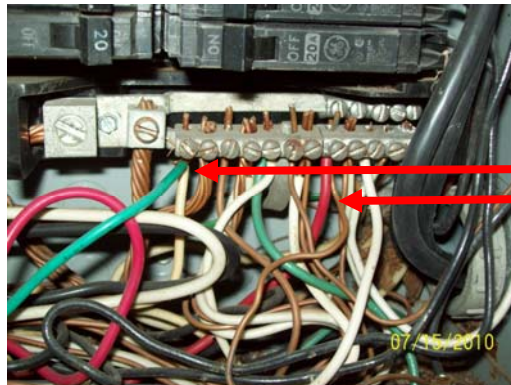
Breakers were not properly labeled.

Double tapping of grounding conductors at bus bar.

Wrong colored conductors being used at the bus bar. These should be white or bare conductors only unless specifically marked.

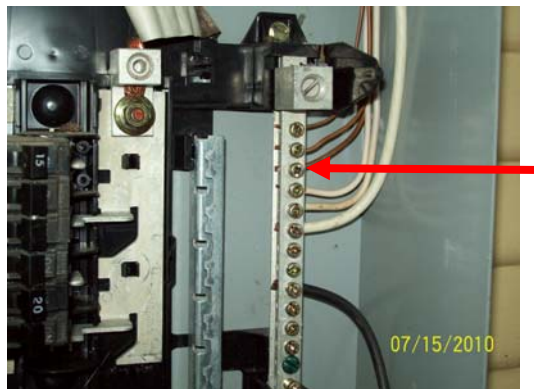
Neutral and grounding conductors are bonded at the bus bar. In a downstream sub panel the white neutral and the equipment grounds must not be bonded together. The neutral must float from contacting the metal enclosure and any equipment grounds.

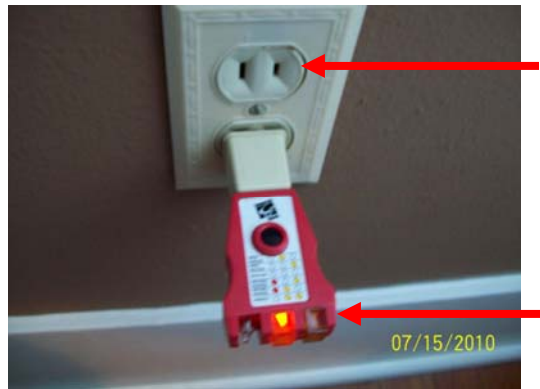
Grounded (three prong) and ungrounded (two prong) receptacles are installed throughout structure.

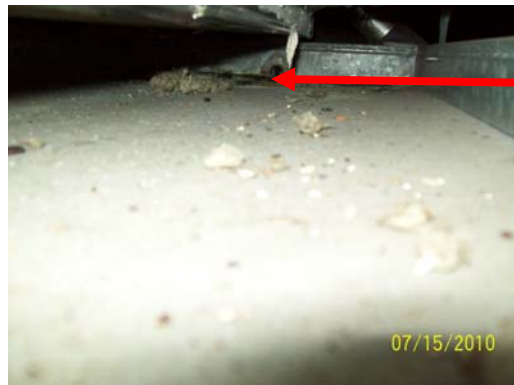
Condensation is leaking from the primary drain pan into the secondary drain pan.

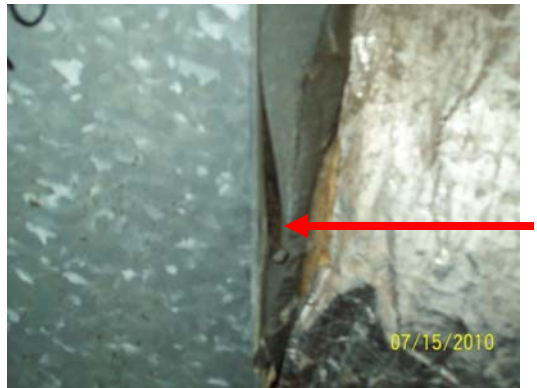
The unit is leaking air into the attic from the metal transition where the duct work attaches.

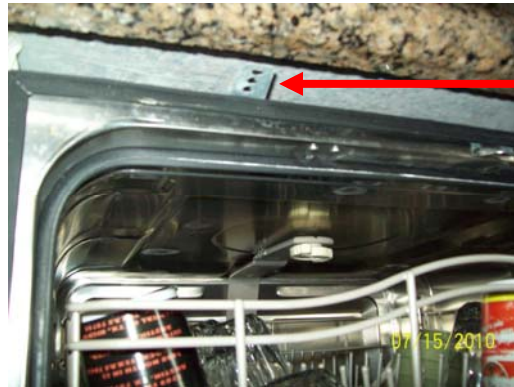
Dishwasher not properly secured in opening.

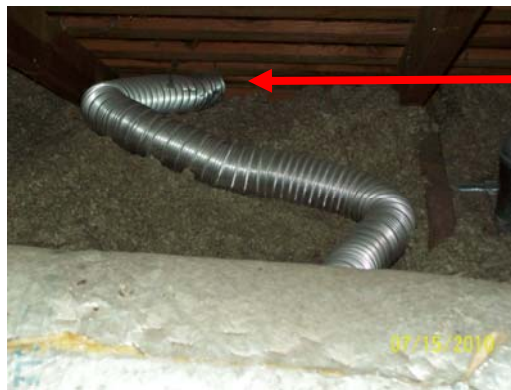
Venting into attic space.
