PROPERTY INSPECTION REPORT

Concerning: 6013 ABC Houston, TX.

Inspected By: Rod Scarborough TREC License # 7189 September 3, 2011

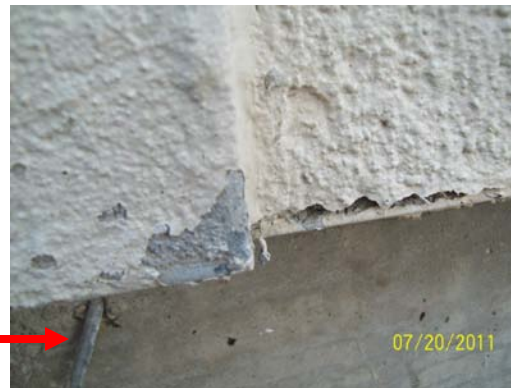
Exposed nail was observed but may not be limited to the north side of the structure. These should be sealed/removed and monitored on a continual basis.

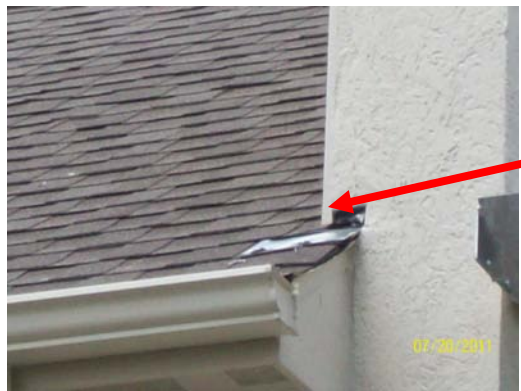
Kickout flashing did not appear to be installed at the northeast corner of the roof at the parapet wall. This should be added to divert water away from the wall.

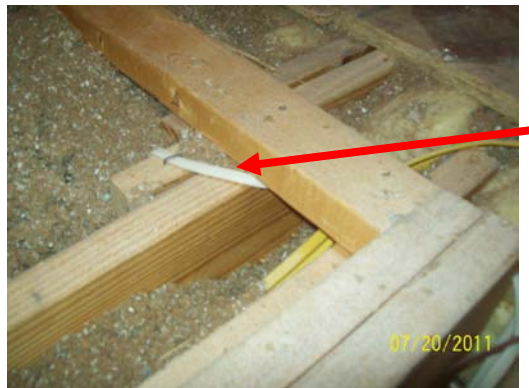
Electrical conductors are not protected within 6' of attic opening. Electrical conductors should be protected within 6' of the attic opening.

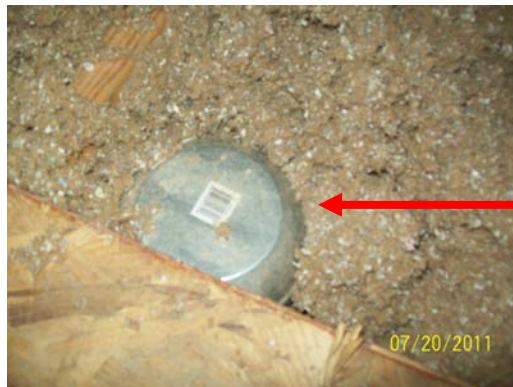
Insulation was observed within 3" of recessed light fixtures. Insulation should be maintained a minimum of 3 inches and wood a minimum of 1 inch from around all recessed fixtures to reduce possible fire hazard. Exception: when lights are listed and labeled as IC (insulation contact) they may be in contact with insulation. No such label was observed.

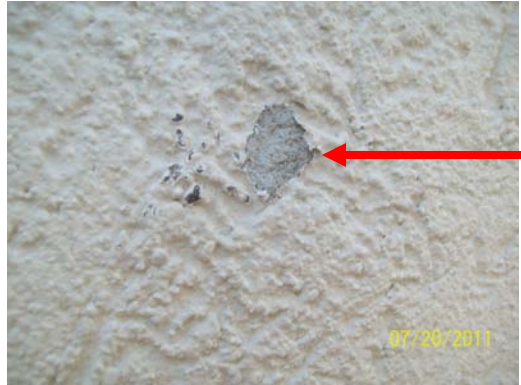
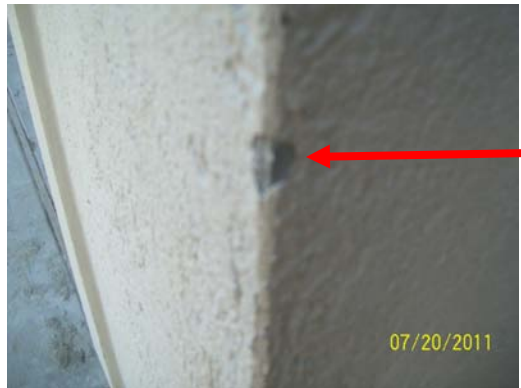
Damage to stucco finish coat was observed at various locations on the north side of the structure. This should be repaired and monitored on a continual basis.

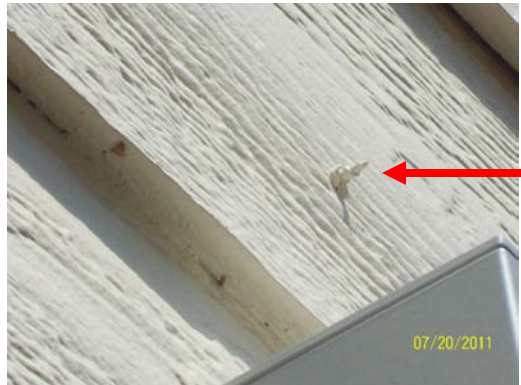
A screw head protruding through the cement board was observed but may not be limited to the area above the light fixture. This should be removed and properly sealed.

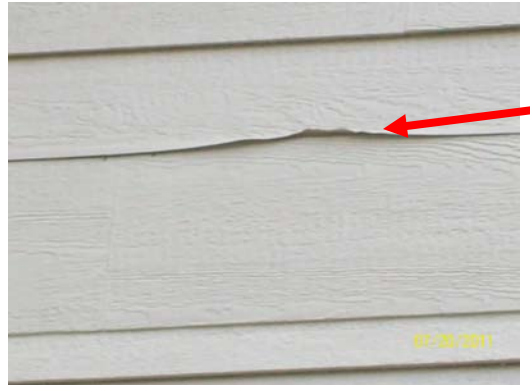
Z-Flashing on the south side of the structure is damaged. This should be repaired.

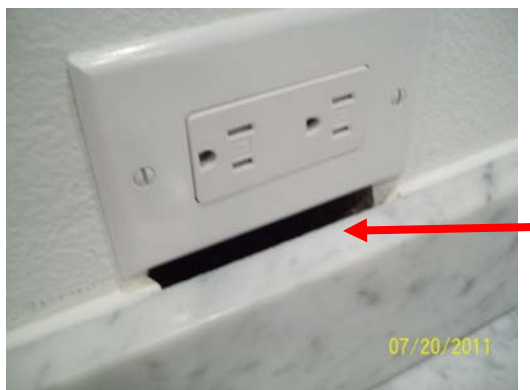
The opening below the receptacle to the left of the cook top in the kitchen needs to be properly sealed.

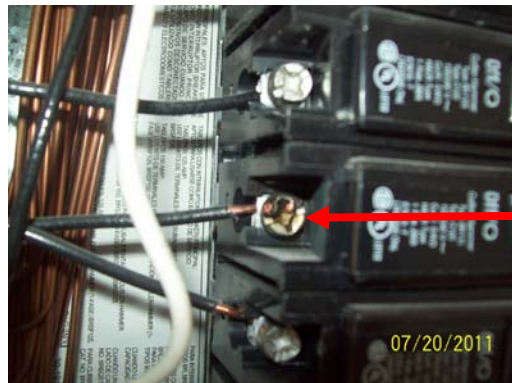
20 Amp breaker shows signs of what appeared to be overheating at the conductor connection/lug. This should be further evaluated by a qualified electrician.

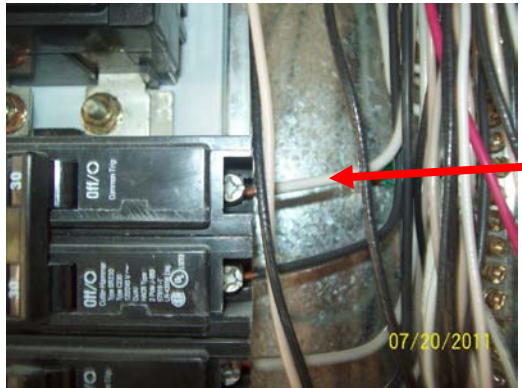
All "hot" wires on breakers should be red or black. Any other color wire should be painted or taped black to indicate that it is "hot". One or more white (neutral) wires are being used as hot wires without marking.

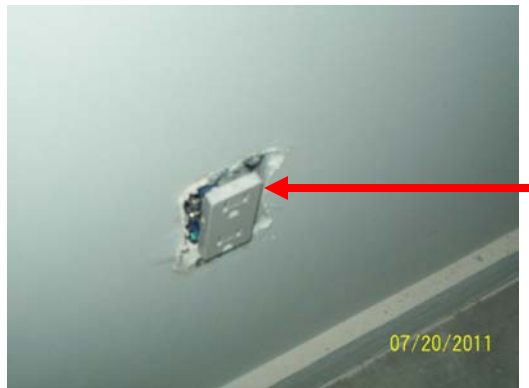
Missing cover plates were observed but may not be limited to the garage. These should be installed and monitored on a continual basis.

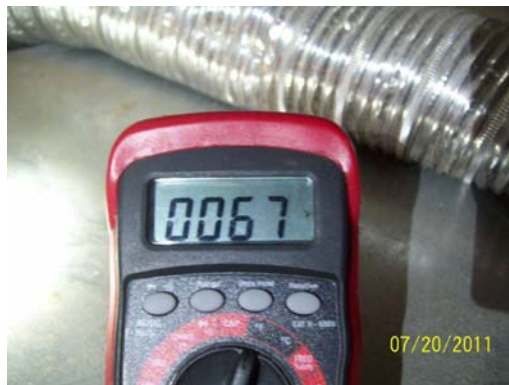
Supply air temp: 67 Degrees Return air temp: 76 degrees (north unit)

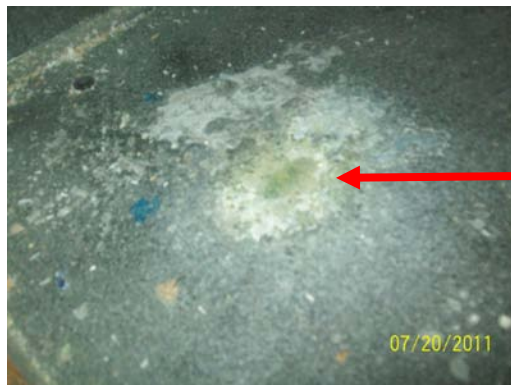
Condensation was observed in both of the secondary drain pans in the attic. Condensation was dripping from the insulation above the pans. This should be repaired and monitored on a continual basis.

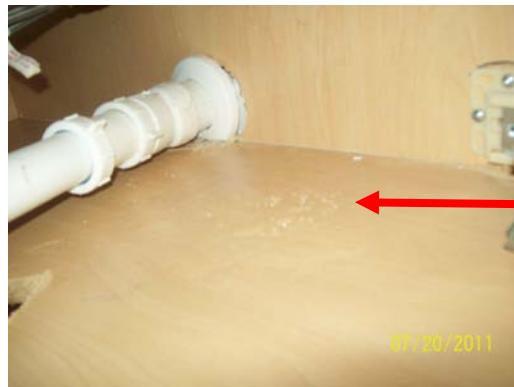
Active leak was observed under the left sink in the master bathroom. This should be repaired and should be monitored on a continual basis.
