PROPERTY INSPECTION REPORT

Concerning: 6013 ABC Houston, TX.

Inspected By: Rod Scarborough TREC License # 7189 September 3, 2011

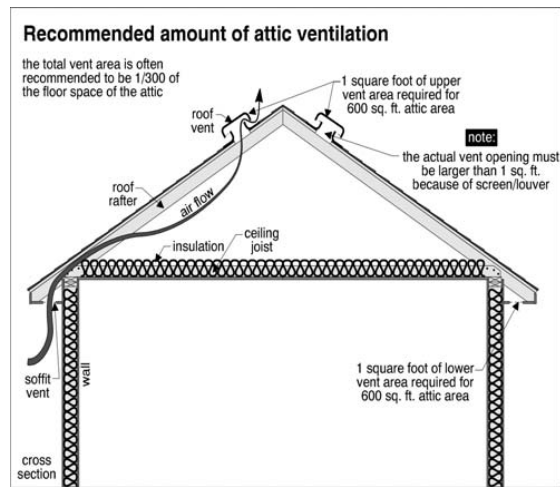
Roof structure/attic appeared to be stable and functioning as intended however there were deficiencies as described below.

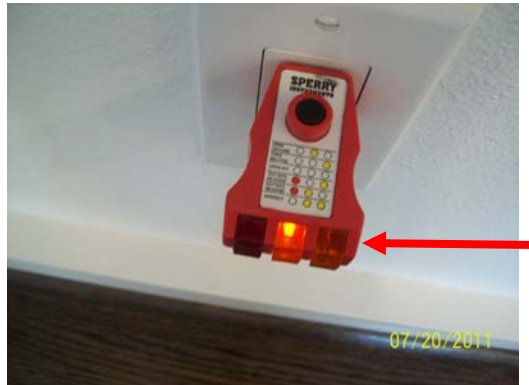
Missing cover plates were observed but may not be limited to the garage. These should be installed and monitored on a continual basis.

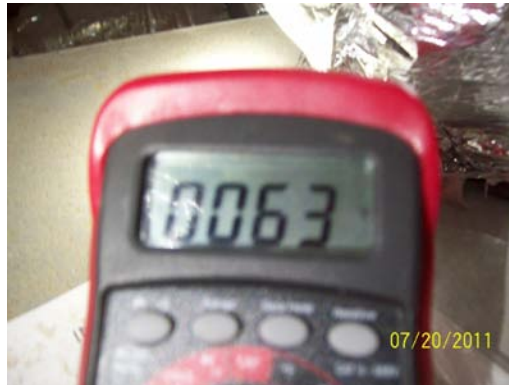
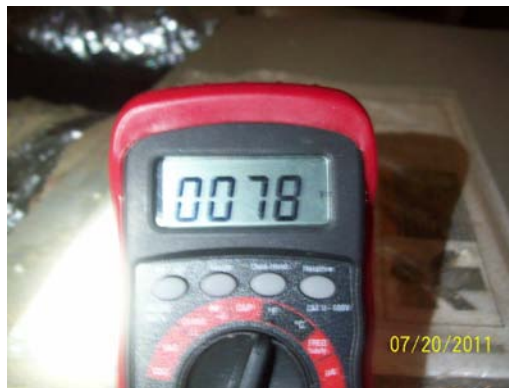
Supply air temp: 67 Degrees Return air temp: 76 degrees (north unit)
